Re-Strengthening Brisbane City Hall: A Case Study of Heritage Engineering

**Submitted in fulfilment of the requirements for the degree
of
Master of Applied Science (Research)**

November 2013

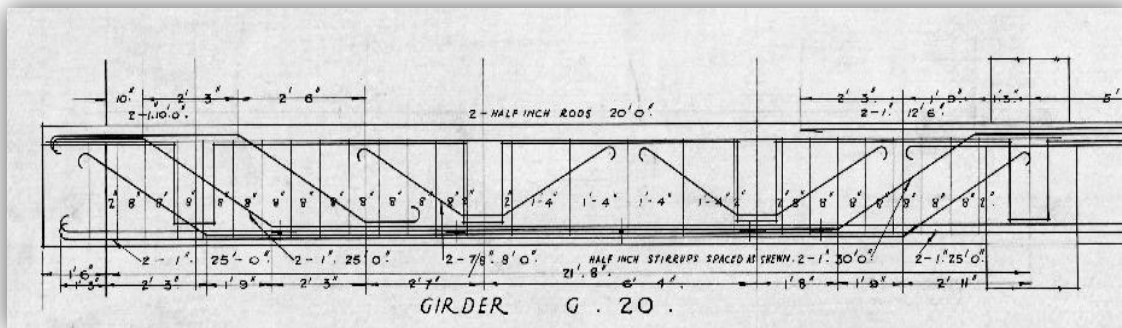
Figure 17 Details showing beam reinforcement (Source: Brisbane City Hall)

A large number of record drawings, both architectural and structural, were available from Brisbane City Council and Brisbane City Library Archives. Figure 17, from a section of the original structural plans, shows typical girder reinforcement. The arrangement of the bars was confirmed by ground penetrating radar (GPR) testing. Unlike the case of modern construction, it appears that most beams were designed and detailed separately as there was very little repetition within the structure in spite of the symmetrical arrangements and almost identical loadings in several locations.

For analysis the properties listed in Table 2 were adopted. Based on the original reinforcement drawings (See Figure 17), the secondary beams were analysed as simply supported, while the primary beams were analysed as having only a nominal continuity at the columns. From this information, the expected concrete compressive strength and the available record drawings, Aurecon undertook an initial structural assessment of the main structural elements coming to the following conclusions. The secondary beams behave in a ductile manner, meaning that the steel reinforcement would gradually deform under tensile stresses. In the event of a structural failure, this would be a gradual process, allowing the building occupants to evacuate before any collapse occurs. The primary beams on the other hand are heavily over-reinforced in the areas where tension would occur. As a result, the mode of failure would be an over-stressing of the concrete in the compressive zone of the beam. Such a failure would be sudden and catastrophic and for this reason compressive failures are not permitted under the current design standards. However the load required to result in this failure was approximately 10 kPa, twice the required imposed floor load, and this was considered to be an adequate factor of safety in normal use (Cartwright & Belperio, 2012).

For both the primary and secondary beams the ultimate load capacity is limited by the shear strength of the concrete sections and typically this was a value of around 2.0 kPa. Although consisting of both ligatures and cranked bars (See Figure 17)

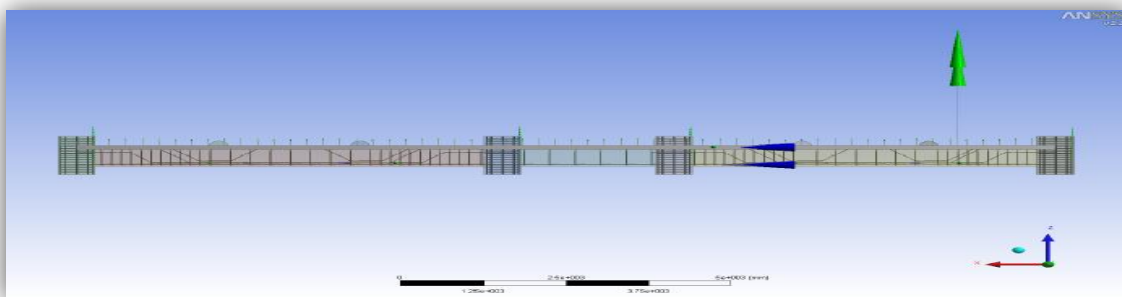
Figure 18 Finite element model for unstrengthened girder (Source: Aurecon)

methods and theories of structural analysis. Nowadays the more popular and faster “finite element method” is available for calculations and modelling, along with the availability of modern computational devices for technical analysis. The term “finite element method” first appeared in 1960 and in a relatively short time became part of everyday engineering language in the abbreviated form of “FEM”. Since the beginning of the 1970s it has evolved a greater level of sophistication in its application (Kurrer & Ramm, 2009). The theoretical analysis of the Brisbane City Hall’s structure required other computer modelling of structural components. For this analysis, Aurecon used ANSYS application software for the simulation and design process. The FEM was made for both strengthened and unstrengthened girders to demonstrate the effectiveness of the methodology and was created to represent the old structure with the unstrengthened girders (as shown in Figure 18), and then another model was created for the strengthened girders conditions (as shown in Figure 19). For both models, an ultimate imposed floor load of up to 4.5 kPa was applied. This was equal to the agreed load limit of 3.0 kPa multiplied by the load factor of 1.5, as given in AS 1170 and AS 3600.

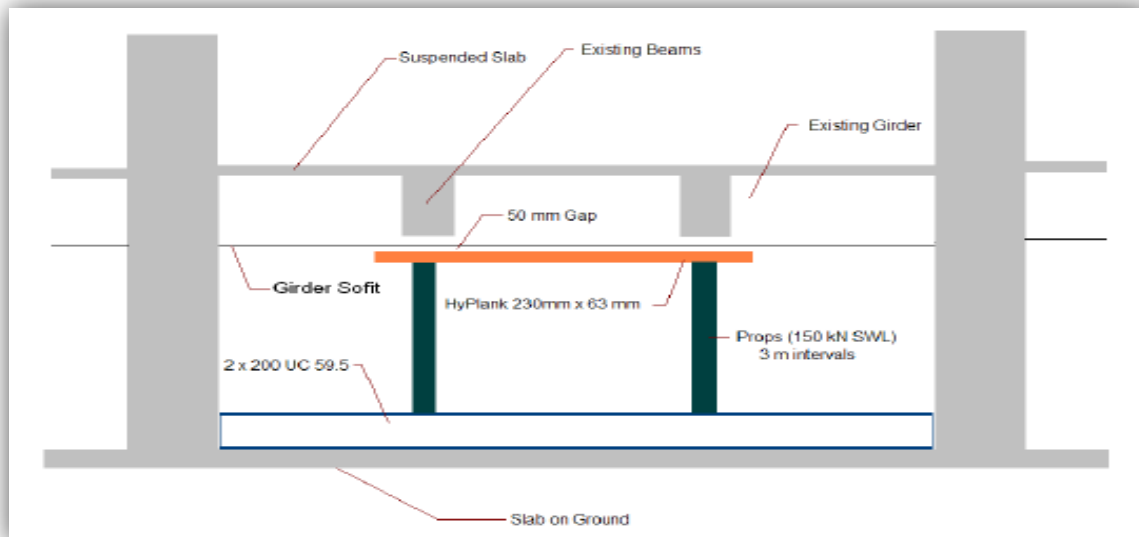
Figure 23 Propping set up devised by Aurecon to check the deflection of beams and girders under loads (Cartwright, 2011)

The test was carried out on level one in the north quadrant of the building (the Balmoral and Oak Table rooms). The objective was to test the typical strengthening works installed on the beams and girders. The soffit of the girders and beams were inspected for existing cracks. The contractor prepared a marked-up plan of the existing cracks in the concrete girders, showing crack width, orientation, location and length.

The beams and girders in the location where the test was to be executed have heavy duty back propping placed under them. A gap of 50 mm was provided between the top surface of the Hyplank and the soffit of the beams and girders in the loading zone. No gap was provided between the top surface of the Hyplank and the soffit of the girders located at the perimeter of the loading zone. Figures 22 and 23 illustrate the testing method that Aurecon devised to ensure the strengthening method was correct.

The results of the load test are summarised in Figure 24, which shows the deflection against the applied load for the onsite strengthened girders, along with the theoretical results for both strengthened and un-strengthened girders (both modelled using finite-element analysis).
